Manhole Inspection Summary

Manhole # S47CC_034MH

Inspection ☐ Is Incomplete Rating: **3) Fair**

Insp Date: **2/4/08 11:23 AM**

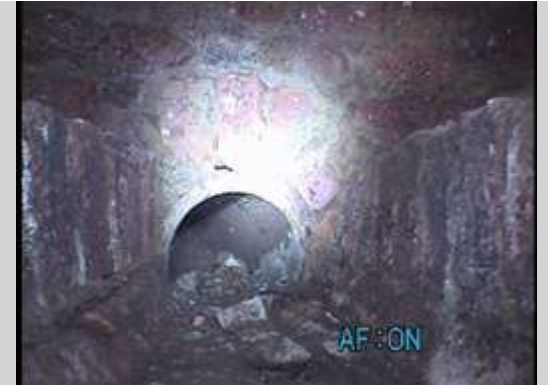
12 O'Clock Outflow

8 in. Circular Gravity Sewer
Pipe Out @ 12 O'Clock

Pipe Height: **8.4** (in.) Rod and Bar (Angled)
Pipe Material: **Clay** ☐ Pipe Lined
Invert Depth: **7.20** (ft.) Flow Characteristics: **None**
Deposits: ☒ None ☐ Mud ☐ Sludge ☐ Debris ☐ Grease
Silt Depth: (in.) Deposits Extent:
Infiltration: **None** Pipe Seal Cond: **Sound**

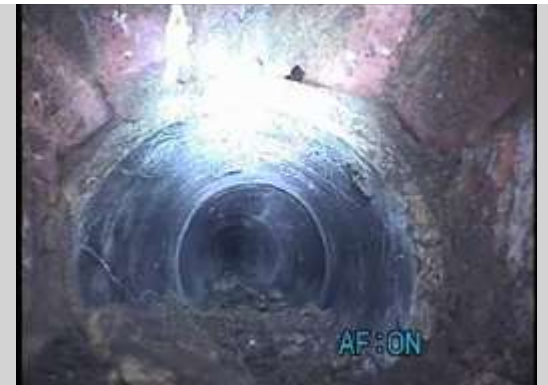
6 O'Clock Inflow

8 in. Circular Gravity Sewer
Pipe In @ 6 O'Clock

Pipe Height: **8.4** (in.) Rod and Bar (Angled)
Pipe Material: **Clay** ☐ Pipe Lined
Invert Depth: **7.10** (ft.) Flow Characteristics: **None**
Deposits: ☒ None ☐ Mud ☐ Sludge ☐ Debris ☐ Grease
Silt Depth: (in.) Deposits Extent:
Infiltration: **None** Pipe Seal Cond: **Sound**
